PRESTRESSED GIRDER REPAIR LOCATIONS

PROJECT NO. 15BPR.18

DAVIE COUNTY

BRIDGE NO. 63

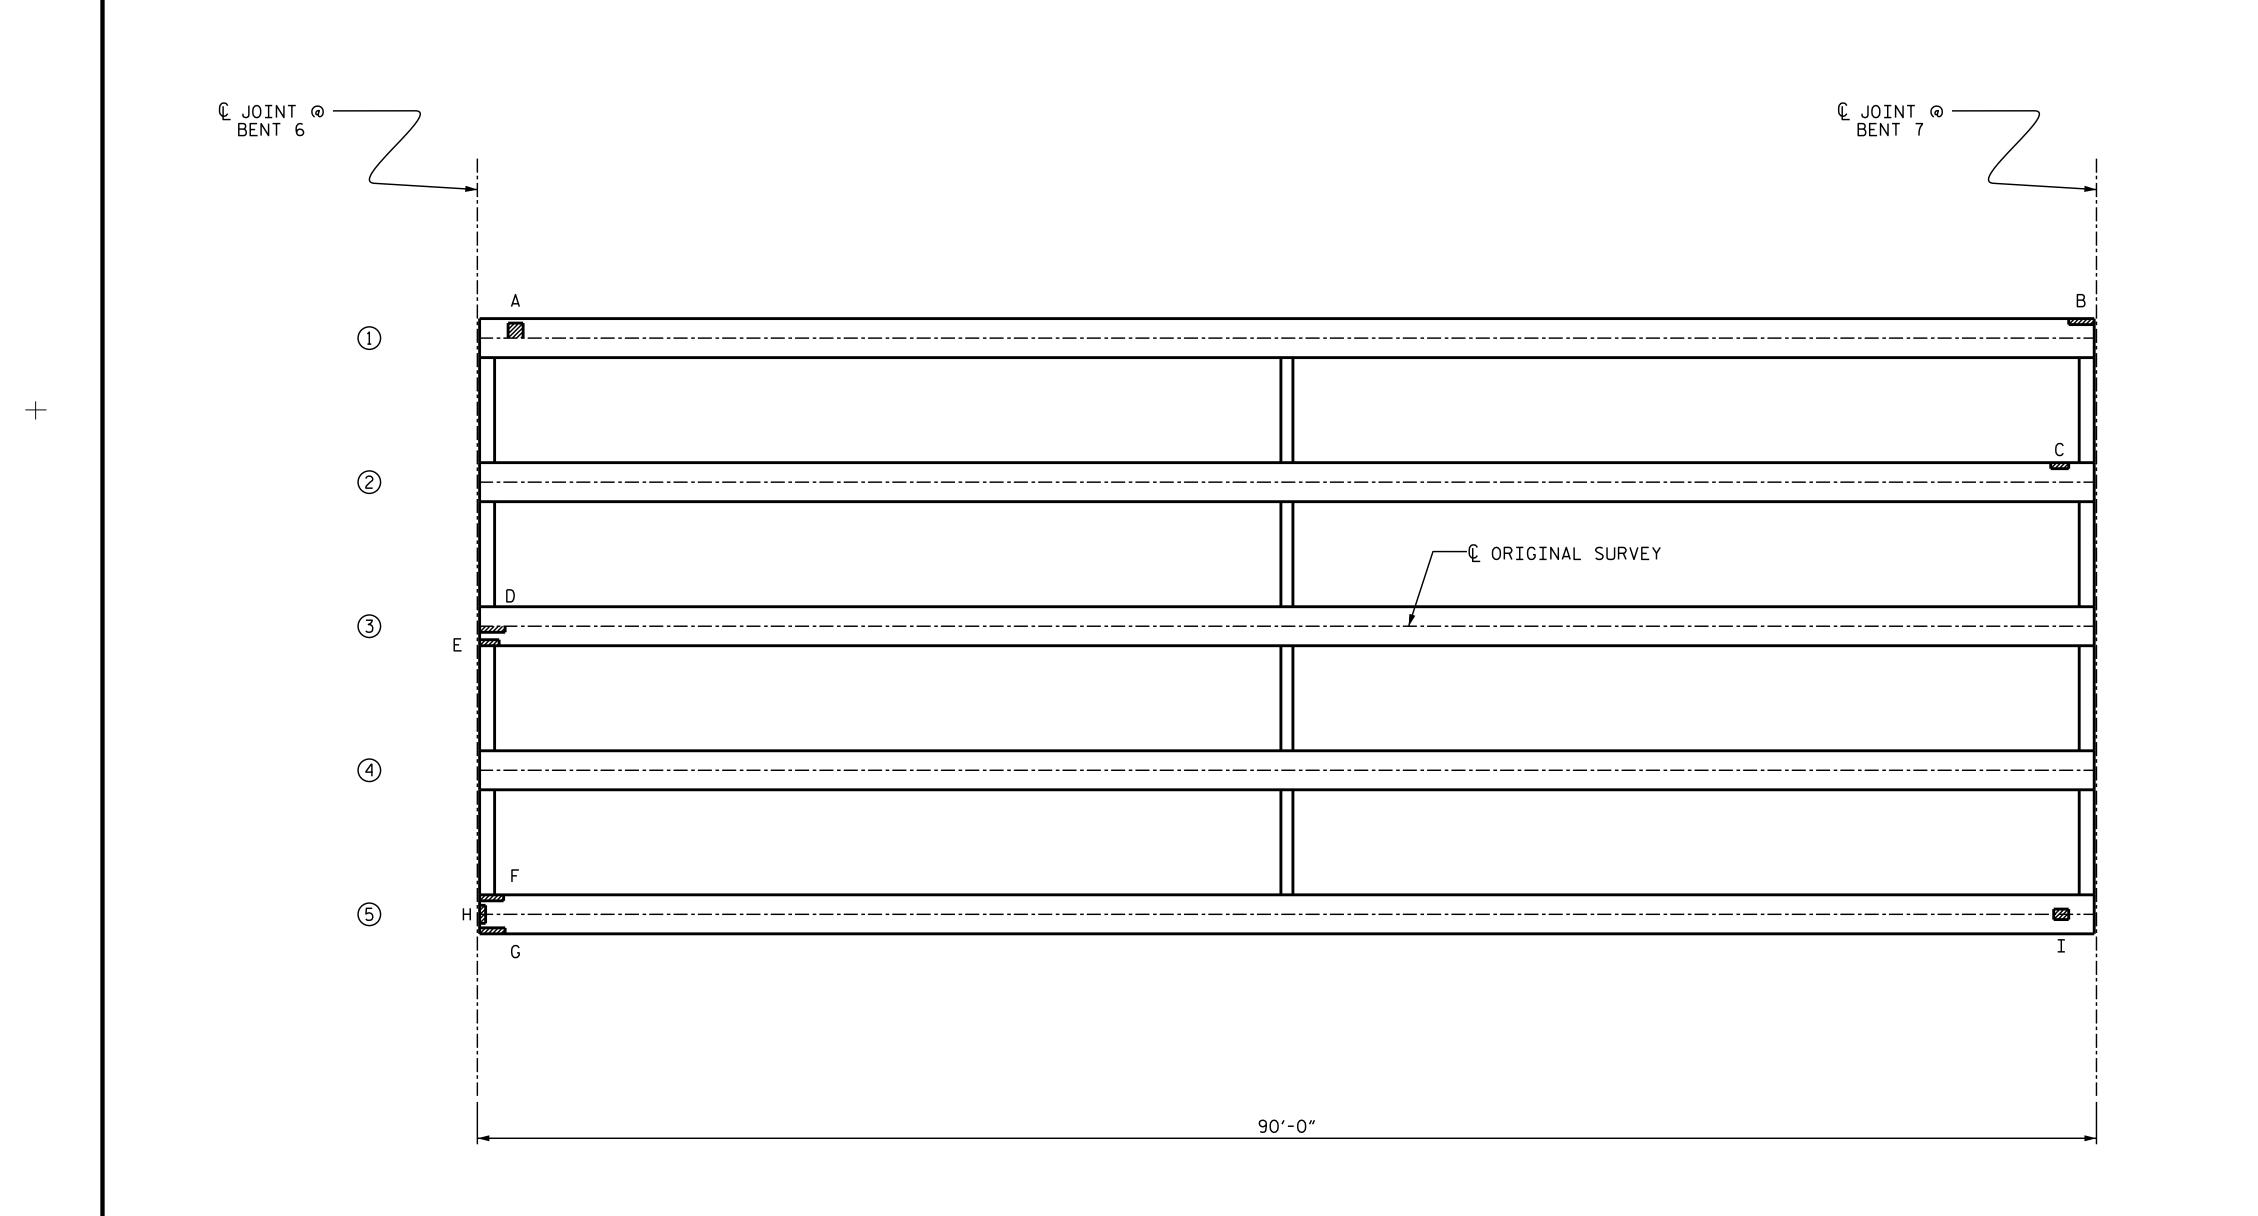
(OTHER LOCATIONS MAY EXIST, SEE NOTES)

THE LOCATIONS AND DIMENSIONS OF THE AREAS FOR REPAIR ARE BASED ON THE BEST INFORMATION AVAILABLE. THE CONTRACTOR, IN CONJUNCTION WITH THE ENGINEER, SHALL VERIFY THE LOCATION AND EXTENT OF REPAIR AREAS PRIOR TO GIRDER REPAIR.

FOR PRESTRESSED GIRDER REPAIR DETAILS, SEE "PRESTRESSED GIRDER REPAIR DETAILS AND SUMMARY" SHEET.
